# Manhole Inspection Summary

Manhole # S19Y\_\_002MH

Insp Date: **6/2/08 9:48 AM**

**Location** Address: **2001 grinnalds av**

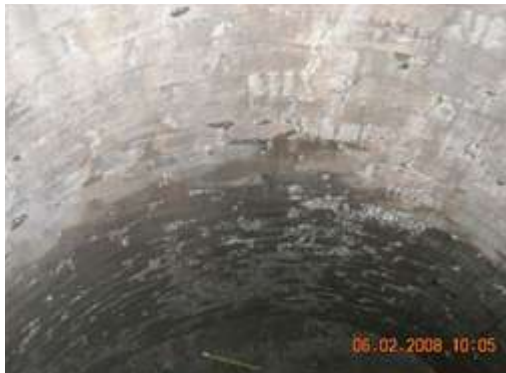
Defect 2

Infiltration: ☐ None ☐ Joint ☐ Cracks ☐ Mortar ☐ Roots ☒ **Wall**

infiltration @ barrel wall

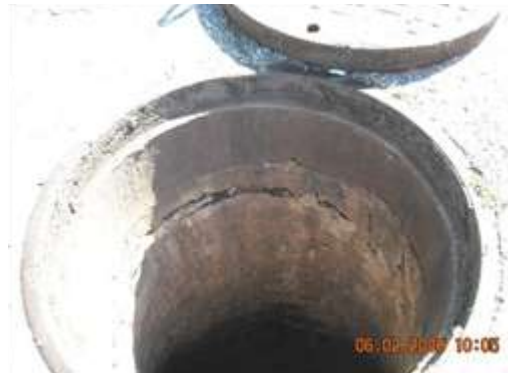
Defect 1

☒ **Leaks**

Condition: ☐ Sound ☐ Cracked ☐ Root Intrusion ☐ Loose Brick ☒ **Deteriorated**

Frame leaks, chimney deteriorated

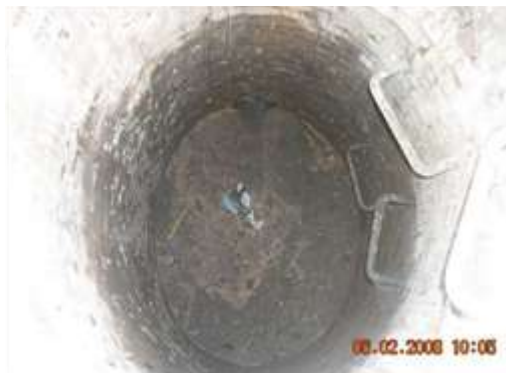
Defect

Count: **4** Missing: **0** ☒ **Corroded**

corroded steps

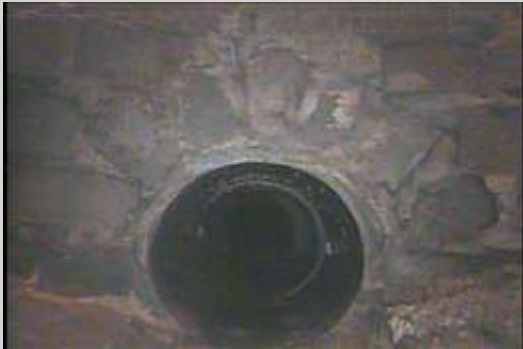
12 O'Clock Outflow

8 in. Circular Gravity Sewer  
Pipe Out @ 12 O'Clock

Pipe Height: **8.4** (in.) Rod and Bar (Angled)

Pipe Material: **Clay** ☐ Pipe Lined

Invert Depth: **8.92** (ft.) Flow Characteristics: **None**

Infiltration: **None** Pipe Seal Cond: **Sound**
